**US Army Corps  
of Engineers®**  
Engineer Research and  
Development Center

## **Double Lap Shear Testing of Coating-Modified Ice Adhesion to Space Shuttle Component Surfaces**

December 2006

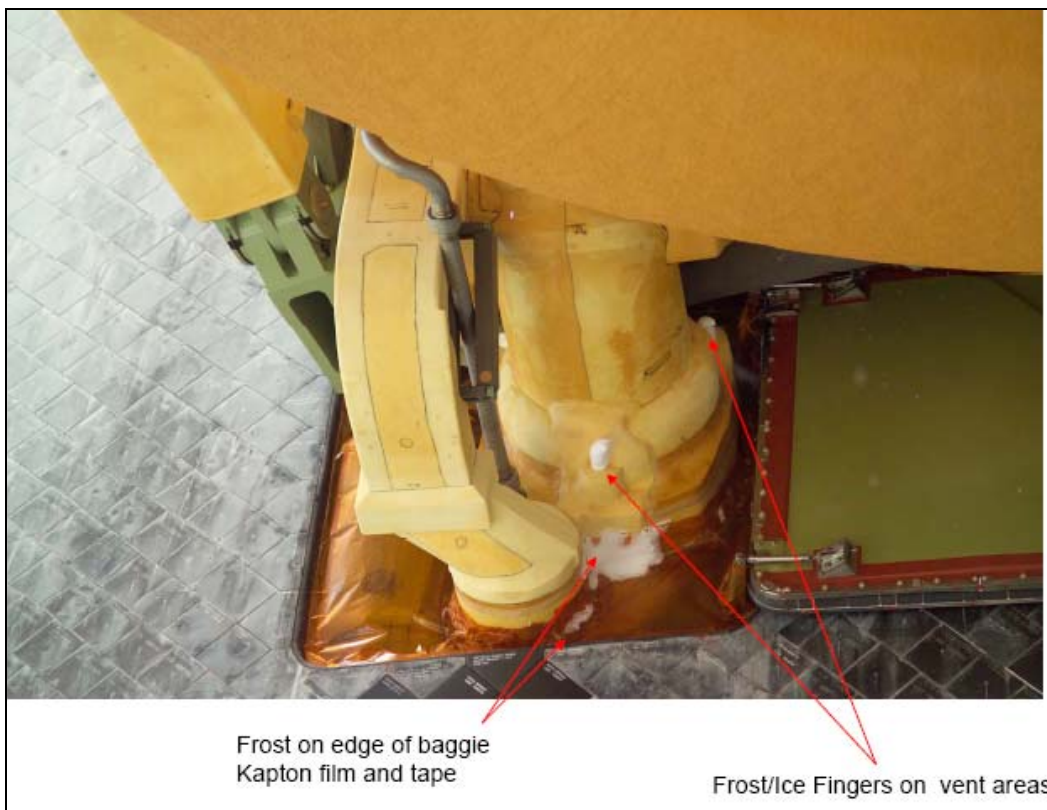
Figure 2. STS-114 LO<sub>2</sub> umbilical area, 13 July 2005 launch attempt.

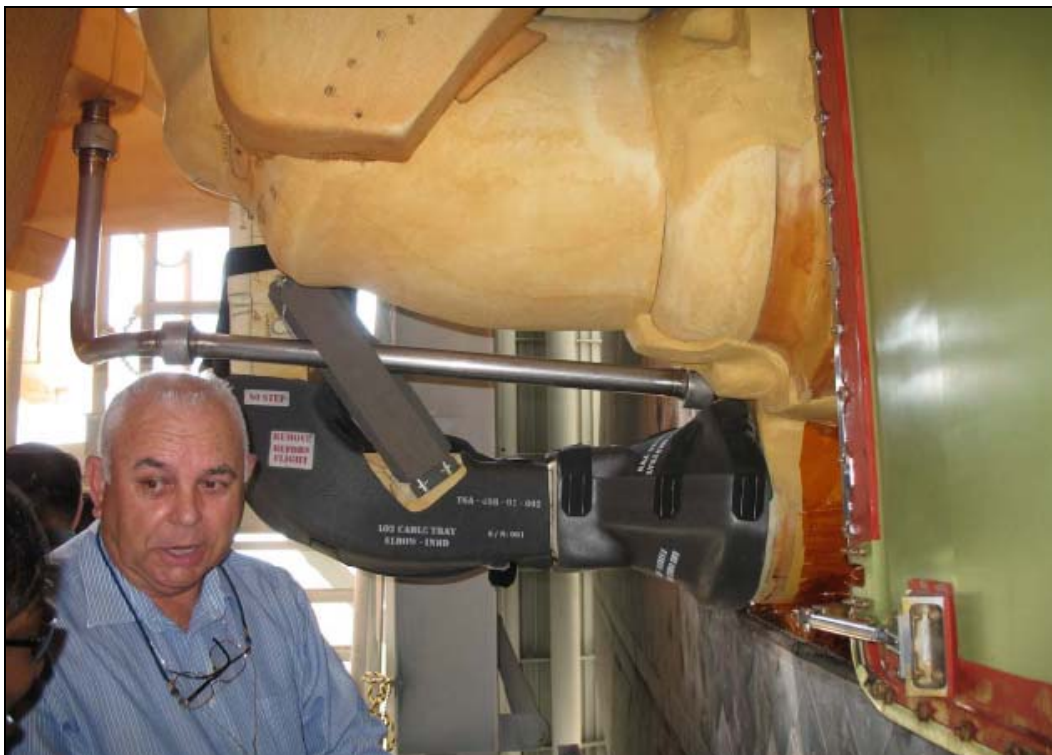
Figure 4. STS-115 LO<sub>2</sub> umbilical area access from the platform on the launch pad, 23 August 2006 preflight inspection.

Constraints imposed on the coating included durability and tolerance of exposure to wind, rain, sunlight, and multiple cryogenic cycles. In addition, the coating must be compatible with already built hardware and require no disassembly, and the application method must be controlled such that the coating is only applied where needed and not to other areas. The test series conducted by Ferrick et al. (2006) identified the outstanding performer of all candidate coatings, named Shuttle Ice Liberation Coating (SILC), which greatly reduced the ice adhesion strength and satisfied the constraints for bracket application. This coating, a mixture of Rain-X and powdered Teflon, can potentially be applied to other areas on the shuttle system that form ice prior to launch. Such areas include the ET/Orbiter umbilical area shown in Figure 1, the ice frost ramps, and the feed line bellows. Figure 2 provides a close-up of the LO<sub>2</sub> umbilical area showing frost and ice development on insulating foam and Kapton film (orange translucent material) surfaces. Kapton film is cut to fit and taped in place while the shuttle is in the vehicle assembly building (VAB). A closer view of this area is presented in Figure 3, where Fire-X (fire retardant) painted foam can be seen in addition to Kapton film and tape. Icephobic coating application could be done in the VAB or from the platform at the launch pad, where easy access and good lighting exist (Fig. 4).

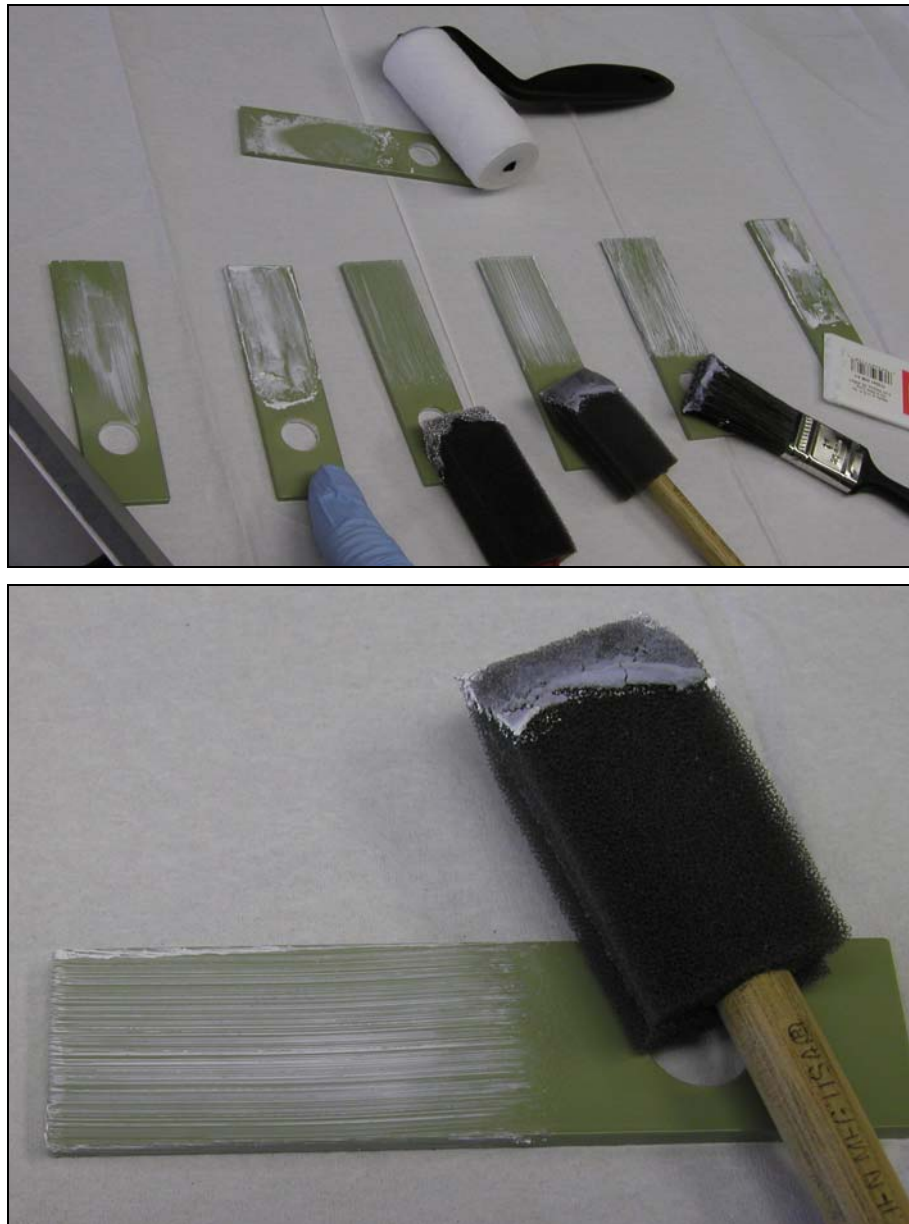
Figure 5. Applicators being evaluated, together with their corresponding coated coupons (top), and close-up of the foam brush with wooden handle and its corresponding coated coupon (bottom).

To find a better application technique for the coatings, several common paint applicators were procured and assessed, including a foam roller, a float, foam brushes, a bristle brush, and a putty knife. These applicators and the resulting coatings applied to test coupons are compared in Figure 5 with that of a gloved finger. As before, the gloved finger gave a thick but even coating. The roller yielded a thick uneven layer, while the float produced a thick uneven layer and pulled the coating off the surface. The foam brush with the plastic handle resulted in a uniform thin coating with some streaking where the foam cells were located, while the foam brush with the wooden handle gave a thicker coating than the other foam brush with the same type of streaking. The bristle brush provided a uniform thick coating with bristle streaks and possible contamination from loose bristles. The putty knife gave a very uneven coating that was extremely difficult to spread. A close-up view of the coating by the foam brush with the wooden handle is also shown in Figure 5, where the improved uniformity is apparent. Based on these results, the use of a foam brush was determined to be the most effective and practical method for applying the SILC. The foam brush with the wooden handle was chosen for use, as it provided the most consistent coverage that was thick enough for application on rougher surfaces.

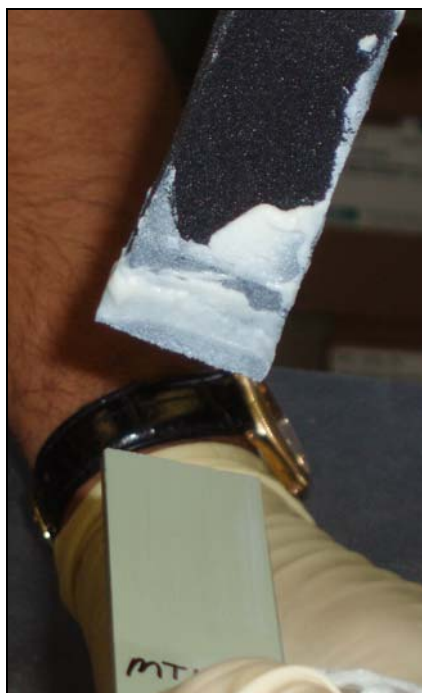
Figure 6. Foam brush filled with SILC prior to application of the coating to the coupon surface.

thin coating was achieved by first applying an ample amount of SILC to both sides of the foam brush, as shown in Figure 6. Then, with one side of the brush, the SILC was applied with one stroke up; the brush was then flipped to utilize the other side, and the SILC was quickly applied with another stroke up. This process was repeated for each side of a test specimen. This application technique was used with each coating evaluated in this experimental program and for all surfaces, including Koropon, Kapton tape, adhered Kapton film, and Fire-X over Koropon.

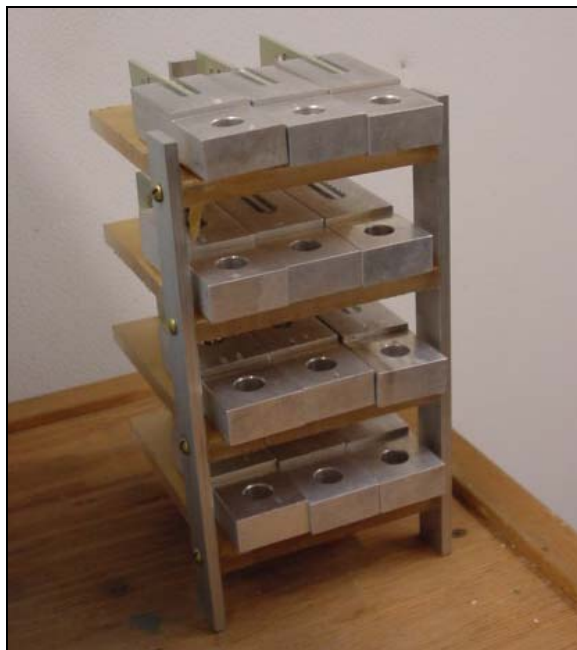
Figure 7. M4, M5, and control samples in the coldroom at  $-15^{\circ}\text{C}$  prior to transport to the test chamber, 30 May 2006.

Following Ferrick et al. (2006), each test specimen was a single coupon measuring 1 in. (2.5 cm) wide, 4 in. (10.2 cm) long, and 0.125 in. (0.317 cm) thick. Ice that was 0.125 in. (0.317 cm) thick adhered to the full width on two sides of the test coupon with a total initial contact area of 2.9 in.<sup>2</sup> (18.7 cm<sup>2</sup>). For consistency this ice was initially grown as strong as possible, and then subjected to temperature decreases comparable to those of the LO<sub>2</sub> feed line bracket. Sample preparation required a full day prior to the start of testing. Each test coupon was placed in a DLS fixture, and tape dams were applied to hold water in place during freezing. These molds were pre-cooled to  $\approx 1^{\circ}\text{C}$ , and pre-cooled distilled/de-ionized/de-aerated water was injected. The samples were then placed in a cold box at  $-10^{\circ} \pm 0.1^{\circ}\text{C}$  ( $14^{\circ} \pm 0.2^{\circ}\text{F}$ ) and isolated under an insulating cover to promote slower freezing. Ice growth and cool-down to the cold-box temperature occurred over 4–5 hours. Following ice growth, samples were placed in the coldroom outside the cold box and allowed to equilibrate at  $-16^{\circ}\text{C}$  ( $3^{\circ}\text{F}$ ) for about 2 hours. Figure 7 depicts a typical set of frozen samples in the coldroom.

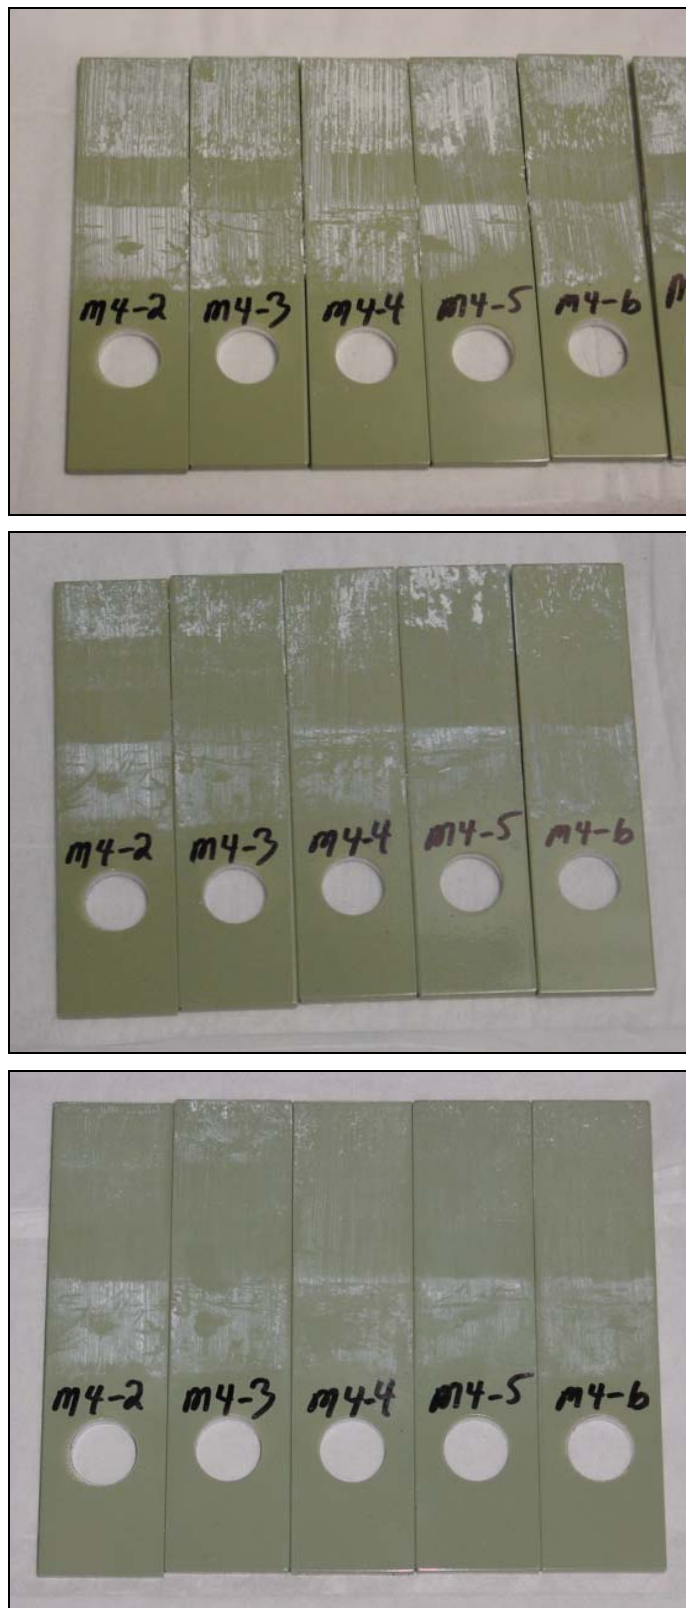
Figure 17. M4 coupons after one (top), two (middle), and three (bottom) test cycles.

Load–time traces for representative individual tests from cycles 1 and 3 are presented in Figure 16. For the M5 group, peak loads were generally higher in cycle 3 as shown by this comparison. The widths of the M5 cycle 1 traces were typically greater than those of cycle 3. In contrast, the M4 peak loads were generally higher in cycle 1 than in cycle 3. However, like the M5 group, the width of the M4 cycle 1 traces were greater than those of cycle 3, corresponding to decreased stick-slip with the removal of excess coating material. Diminished load in response to increased strain rate was typical for both M5 and M4 samples. Post-test analysis of these sample groups revealed smooth ice at the interface with the coupon that did not show evidence of damage from testing, and coupons moved easily by hand. Decreasing amounts of coating retained on the ice surface following each successive cycle indicate repeated failure within the coating. The progressive loss of coating from the M4 coupon surfaces is visible in Figure 17, which shows this set of samples after each test cycle.

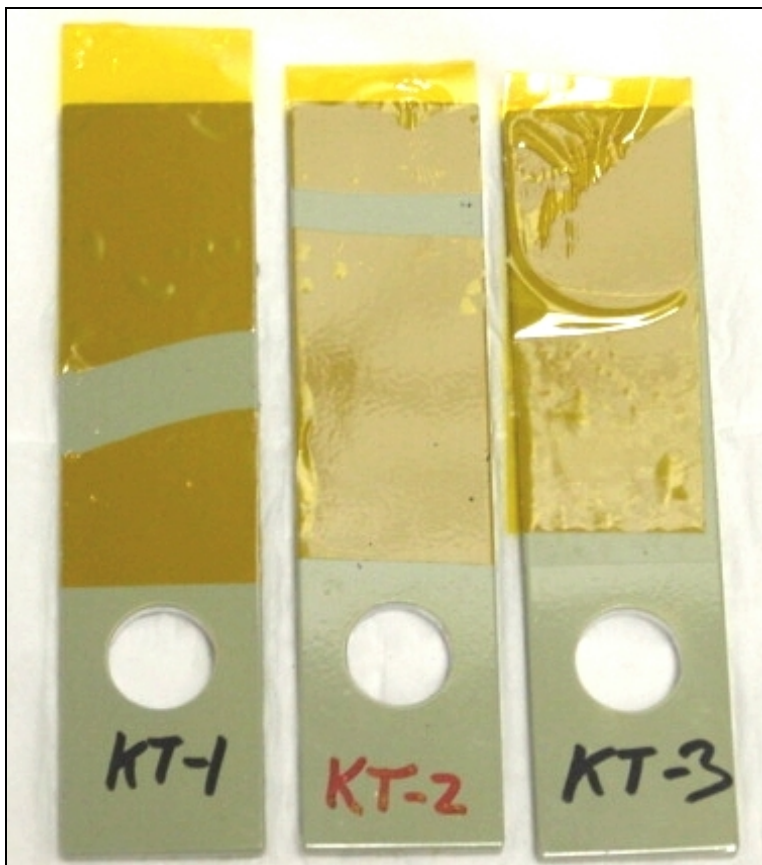
Figure 18. Failed Kapton tape and adhesive resulting from uncoated DLS testing.

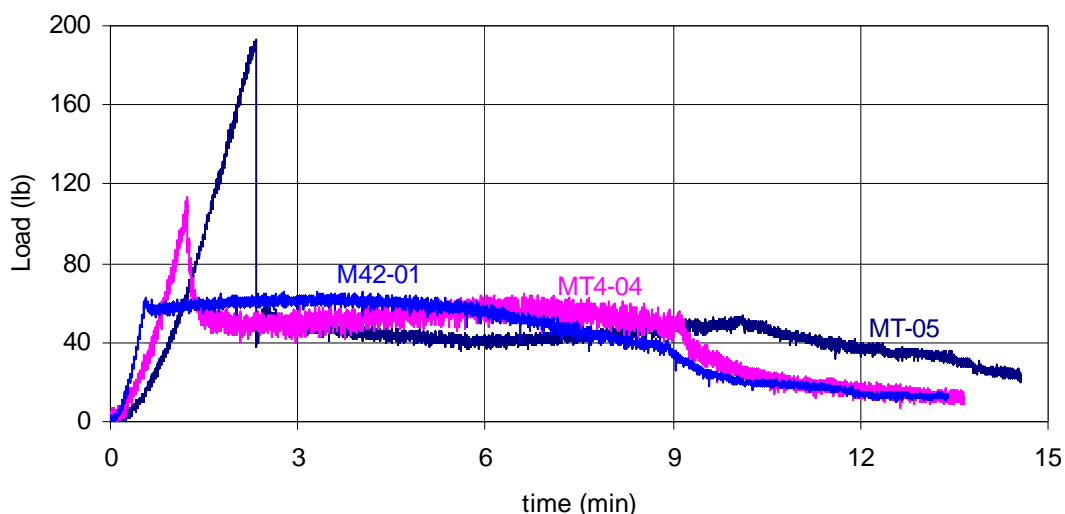
Figure 21. Load-time traces of representative M42, MT, and MT4 tests in cycle 1.

The effect of the addition of the UVA on cycle 1 adhesion performance of the SILC mix can be seen by comparing MT (8% UVA) and MT4 (4% UVA) with M42 in Table 6. The peak loads developed by both UVA mixes are higher than those of M42, but total work was essentially unchanged. Load-time traces for tests that are typical of each series are compared in Figure 21. An initial high peak load was typical of both UVA coatings, occurring in four of the five tests of each. Following this peak, the loads decreased sharply and became similar to those of M42 over the remainder of the test. The cycle 1 results indicate that the extent of mixing during coating preparation may have a comparable or greater effect on ice adhesion to the SILC than the addition of UVA. However, corroborating data from higher test cycles are needed to confirm this observation.

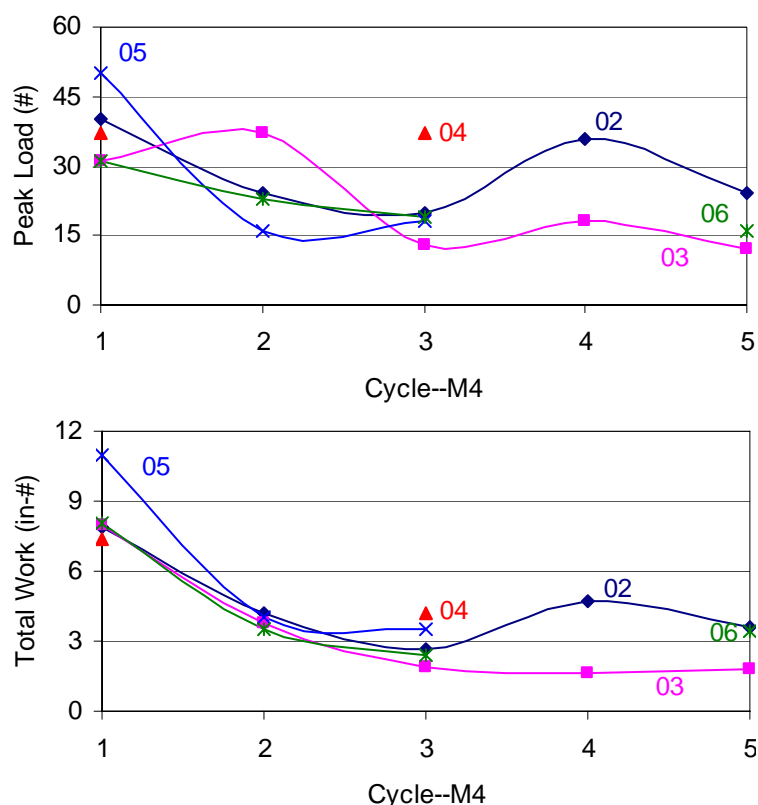
Figure 26. Peak load (top) and total work (bottom) of individual M4 coupons through five test cycles.

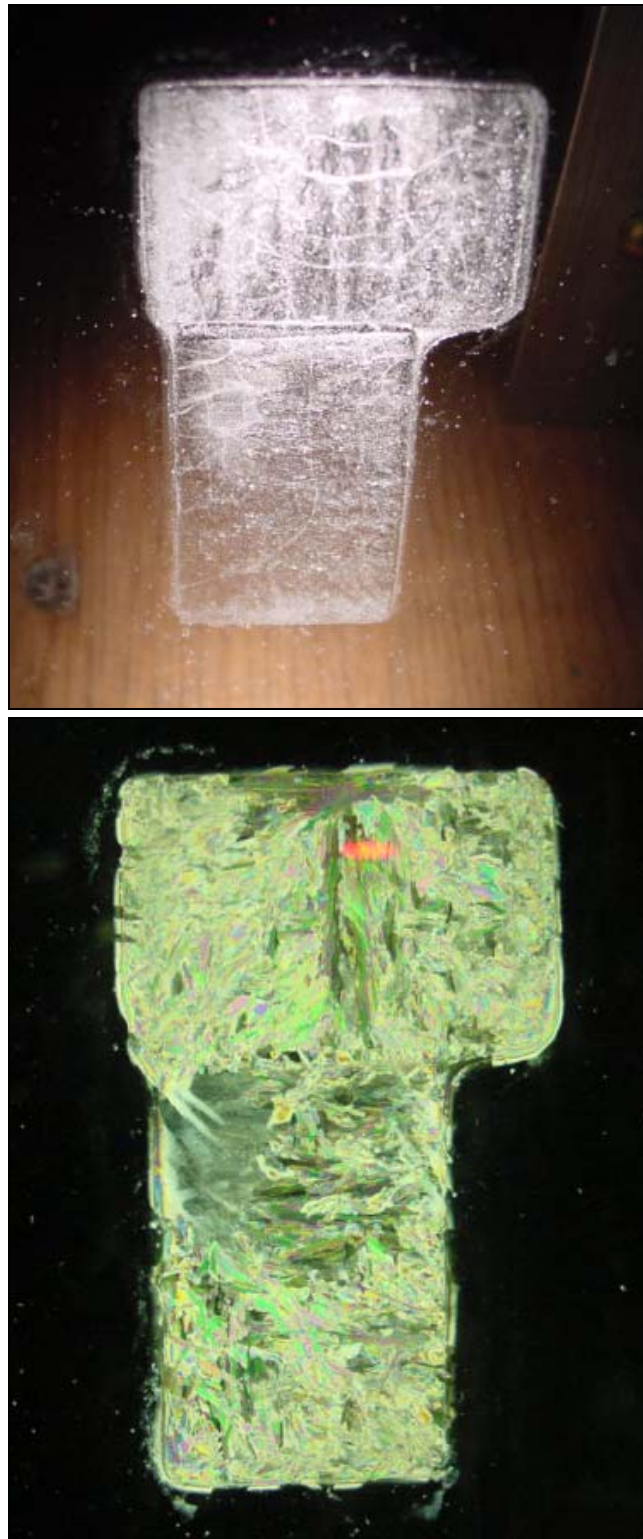
Figure 29. Ice samples from two sides of mold M4-2(5) with point backlighting (top) and cross-polarized light (bottom).
